# Stream Crossing Infrastructure Planning Guidance

December 2024

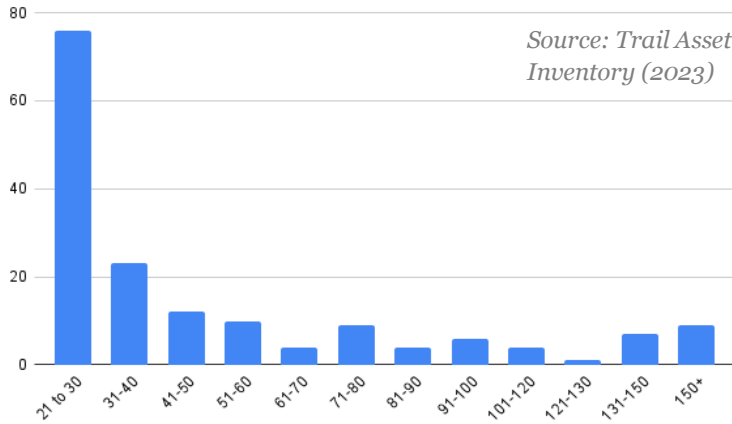
## Appendix A: How Many Bridges Are On the A.T.?

Bridges in total: 414  
 Bridges over 20ft: 185  
 Greater than 150ft: Some highway bridges  
 James River (Foote) Bridge: 632 ft  
 Thundering Falls VT (Boardwalk): 845ft
