ESSENTIAL MAINTENANCE MODULE

KEEPING HIKERS ON THE CENTERLINE

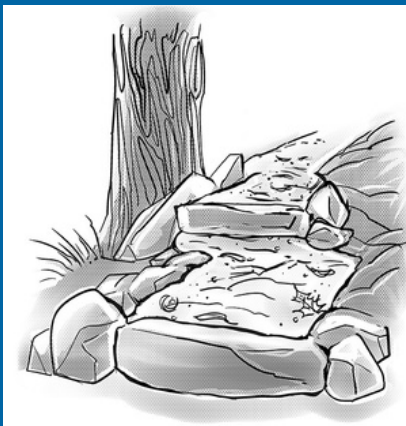
Brushing vegetation in growth seasons, especially uphill of the trail since it tends to push hikers to the outside edge.

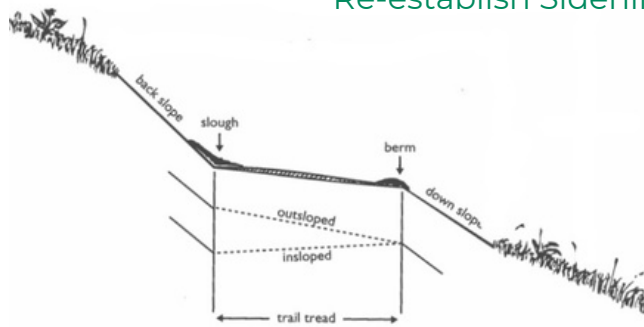
Re-establish Sidehill Trail

Sections of sidehill trail are subject to narrowing as gravity and water begin to release sediment from the backslope into the inside edge of the trail. Hikers, seeking more stable footing, begin walking the outside edge of the trail. By resetting the backslope at a 45 degree angle and redefining the tread width to 18-24" with a 3-5% outslope, maintainers can bring hikers back toward the centerline.
